Building energy **Performance Gap**– possible causes and the role of users, operators and design standards

«Performance gap» is the term used to describe the difference between the theoretical and actual energy consumption of buildings.

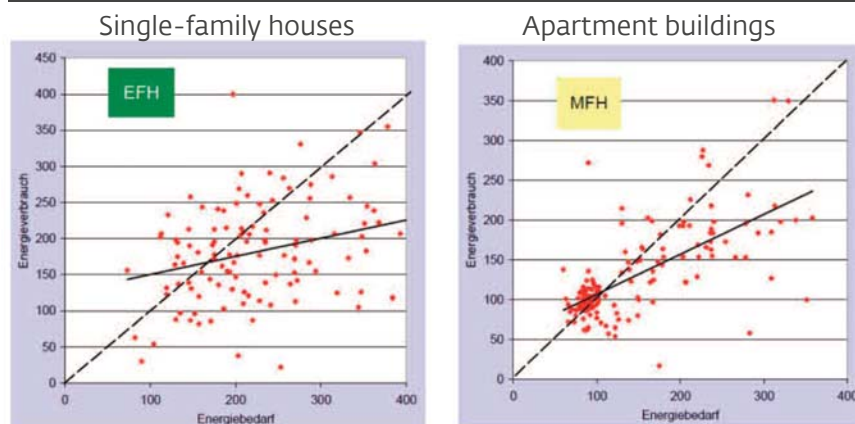
Performance Gap – International German energy certificates – performance of 3400 dwellings

Source: M. Sunikka-Blank & R. Galvin (2012): Introducing the prebound effect: the gap between performance and actual energy consumption, *Building Research & Information*, 40:3, 260-271

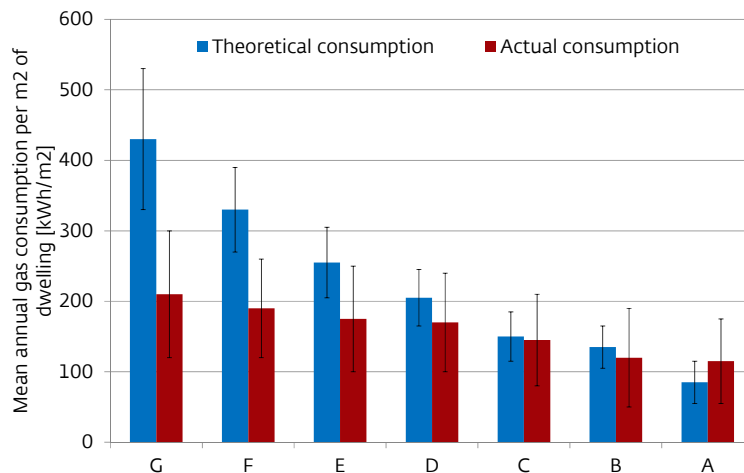
Gas consumption of 200'000 Dutch dwellings

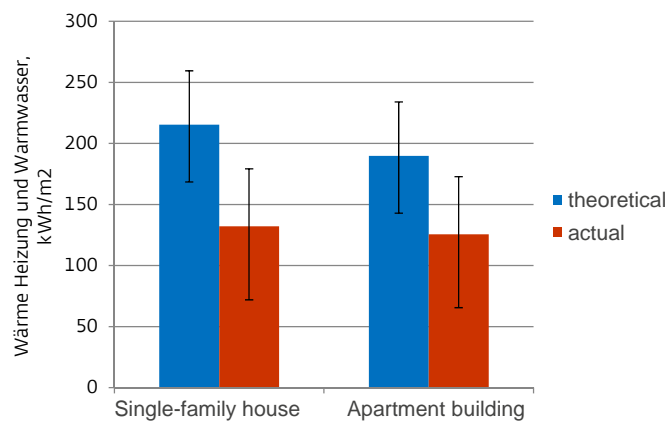
1. Energy-Coaching of Zurich: Evaluation of 65 dwellings

Space heating energy and warm water consumption (kWh/m²)

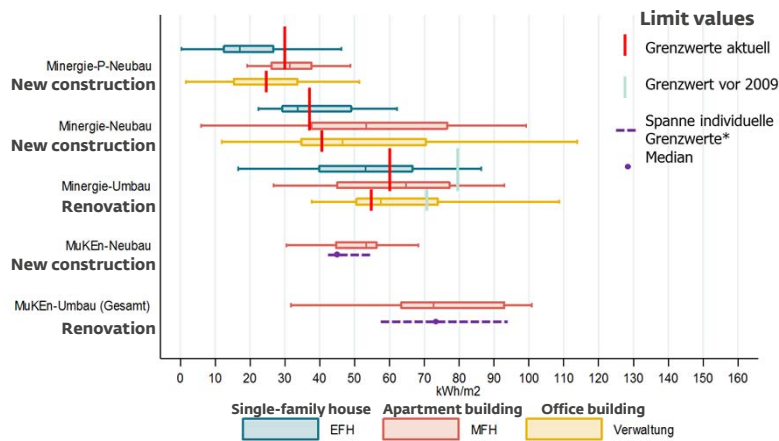
Performance Gap - Switzerland Energy consumption index (kWh/m²)

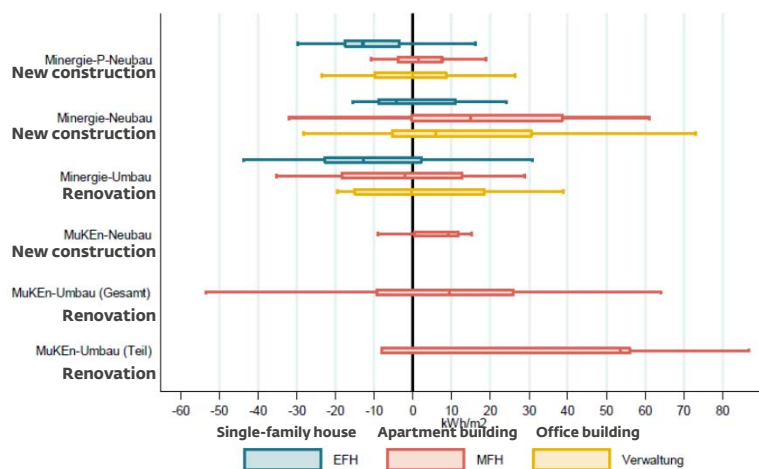
Performance Gap - Switzerland Weighted energy consumption index – Deviation from limit values

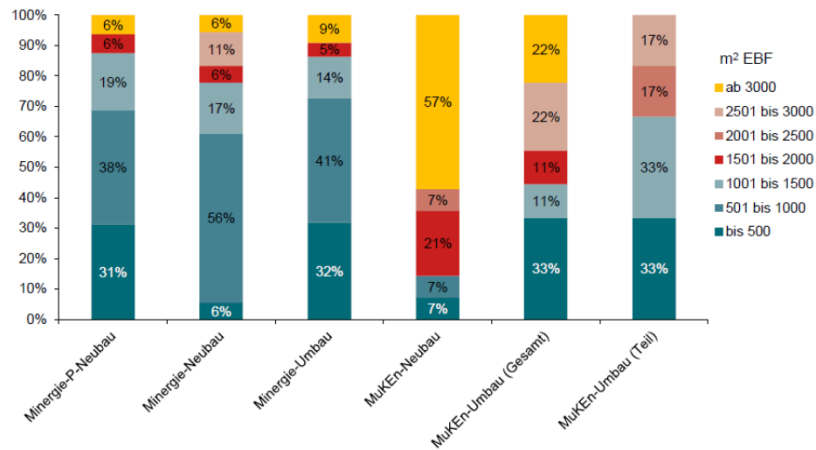
Performance Gap - Switzerland Distribution of building size (energy ref. area)

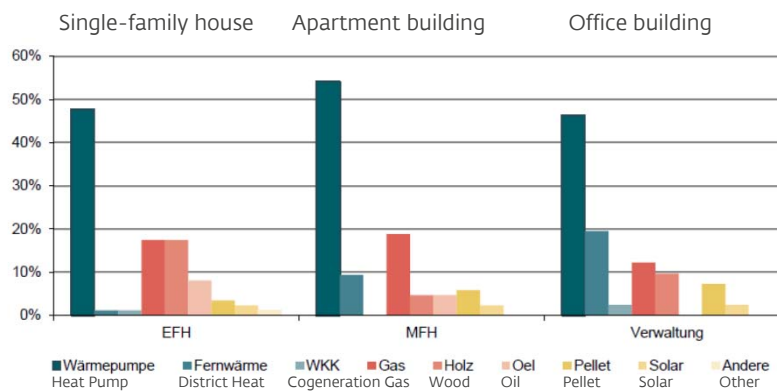
Performance Gap - Switzerland Distribution of heating systems

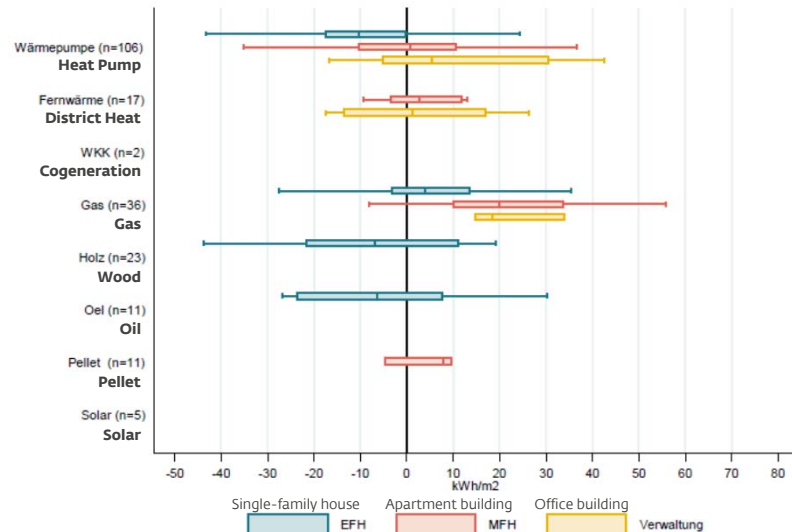
Energy consumption index vs. heating system

Possible causes for the exceeding energy consumption in apartment buildings

Observations during on-site inspections:

1. Functional problems or faulty settings in the building systems
2. Low efficiency level of the heating system (high supply or boiler temperatures)
3. High energy consumption due to heat tape ("bande chauffante") and heating rods in boilers.

➤ Conclusion: By setting the basic parameters of the heating- and ventilation systems, operators have a *much bigger influence* on the level of overall energy consumption than the users.

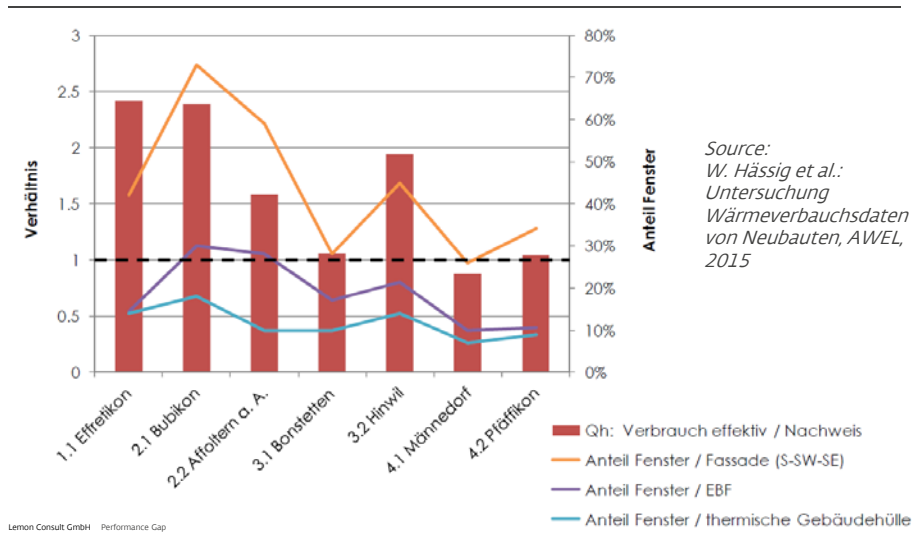
3. AWEL-Study: Analysis of contractor data

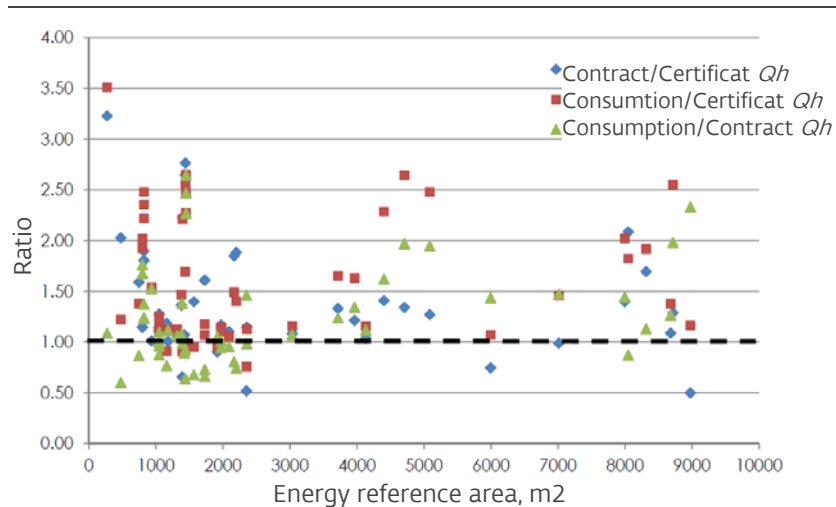
Analysis of contractor data - heating

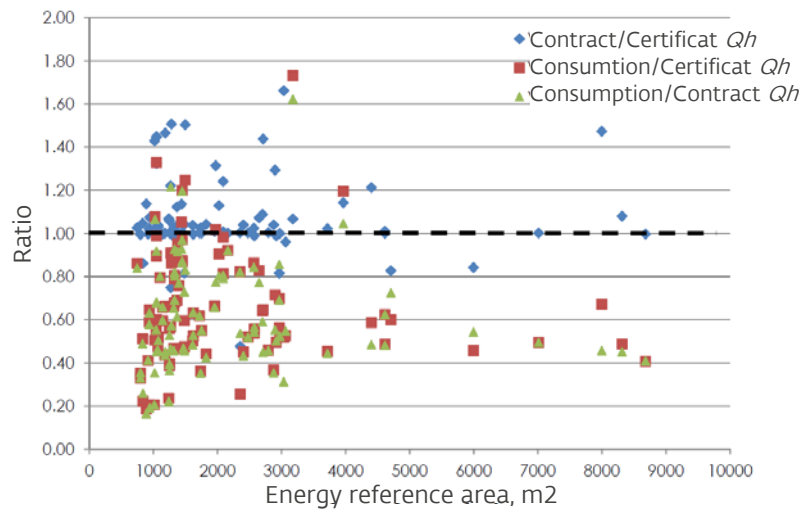
Analysis of contractor data – hot water

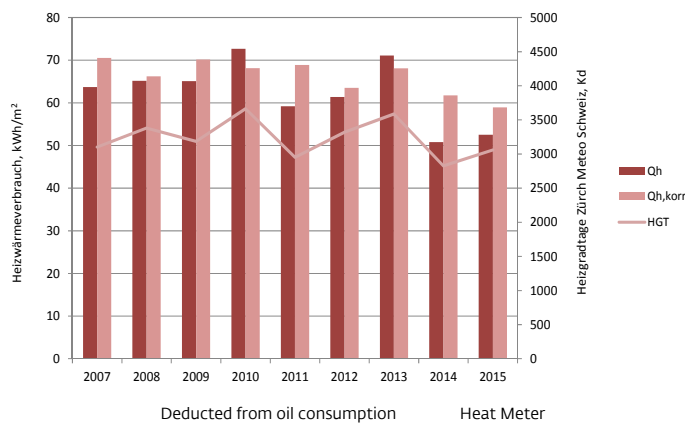
Performance Gap – Existing buildings Apartment building - Actual heating consumption

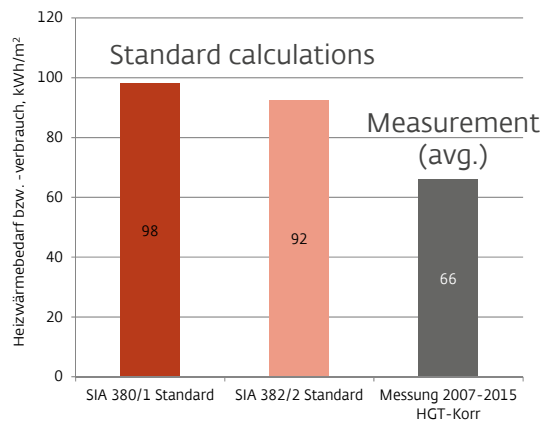
Performance Gap - Existing buildings Apartment building – Standard calculations vs. actual heating consumption

- Based on *standard parameters* (both SIA 380/1 and SIA 382/2) results in **performance gap + 40 to 50%**
- Based on *measured parameters (incl. user behaviour)* makes it even worse -> **performance gap + 110%**
(This is mostly caused by higher indoor temperatures and lower internal gains even though ventilation losses were lower than the standard.)
- Based on *measured parameters (incl. user behaviour and local climate)* -> **performance gap + 20%**

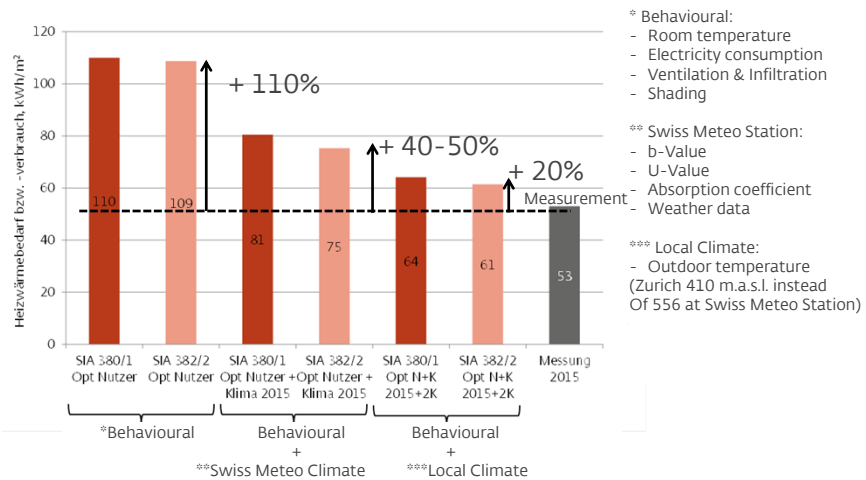
Performance Gap - Existing buildings Apartment building – Calculations based on measured data

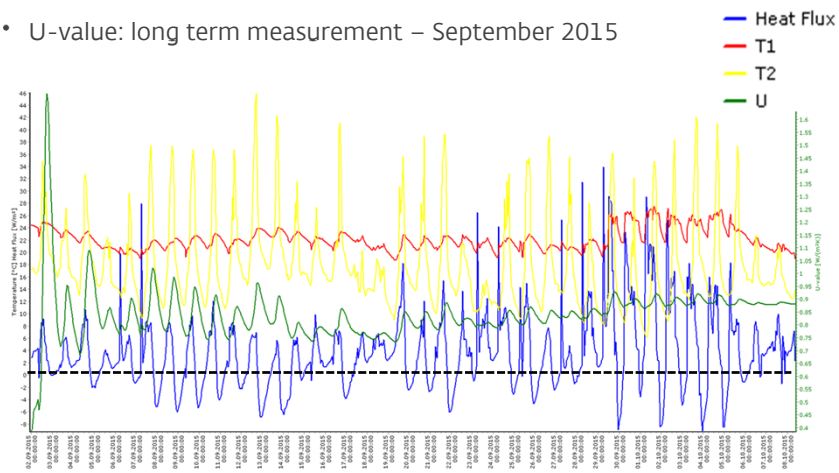
Performance Gap - Existing buildings U-Value Measurements with greenTEG

- U-value: long term measurement – September 2015

Method	Absorption coefficient	Heat transfer coefficient h_i / h_e W/m ² K	U-Value W/m ² K
Messung dT gemessen 2015/16	-	-	1.40
Messung dT Standard SMA 2015/16	-	-	1.05
Berechnung statisch	-	7.7 / 25	1.37
Berechnung statisch	-	5.6 / 4.0	1.01
WUFI Simulation Putz hell	$\alpha = 0.3$	5.6 / 4.0	0.96
WUFI Simulation Putz dunkel	$\alpha = 0.6$	5.6 / 4.0	0.86

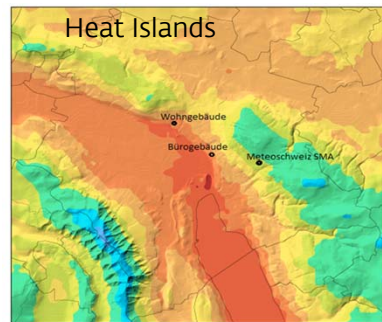
Local Climate 2015 + Urban Heat Islands

Monthly averaged temperatures
